# Optimizing Conveyor Performance with System Upgrade

## PROBLEM SUMMARY

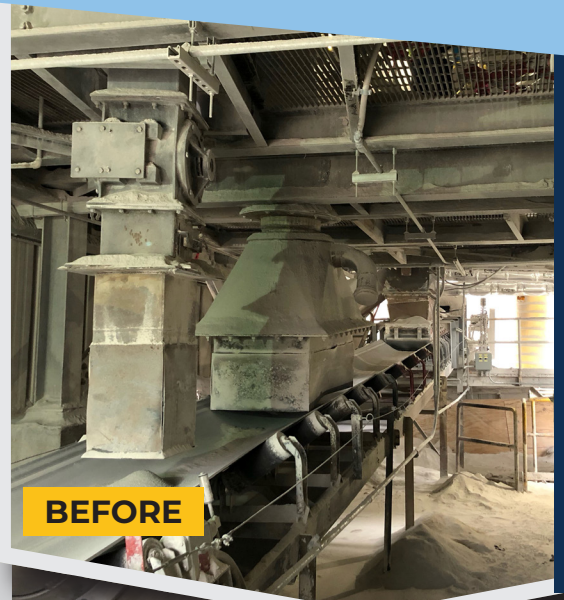
**BEFORE**

A cement manufacturing facility was facing significant spillage and airborne dust issues that affected multiple conveyor systems. The underlying problems stemmed from worn skirting systems, deteriorated wear liners, and an improperly located dust collector pick-up. These deficiencies led to continuous spillage along the conveyors and an ineffective dust collection system. As a result, the area surrounding the equipment became excessively dusty, complicating maintenance efforts and posing health risks to workers. Additionally, the spillage led to financial losses due to the wasted product, further impacting the plant's efficiency and bottom line.

The project focused on upgrading the conveyors to eliminate spillage and reduce dust. Approximately 45 feet of Benetech's MaxZone® Skirting System was installed on one conveyor, effectively sealing the load areas up to the discharge pulley. Additionally, the dust collection pick-up was relocated to enhance its efficiency. The remaining conveyors had their load zones rebuilt using Benetech XN Liners®, which successfully sealed the sides and eliminated spillage.

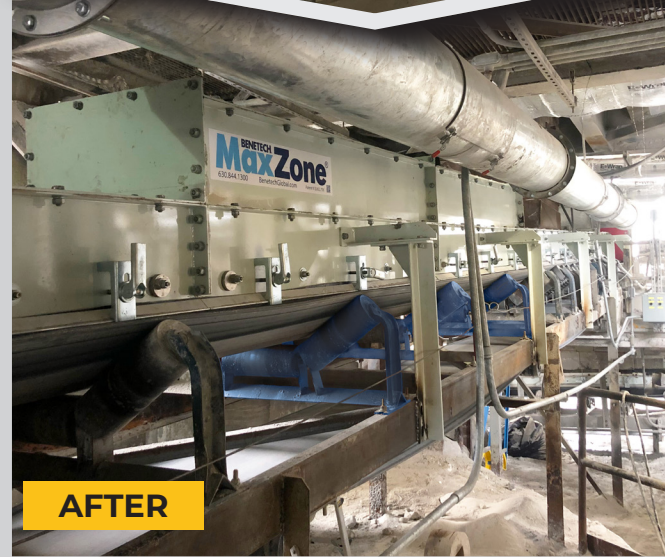
**AFTER**

Benetech's solutions produced exceptional results, transforming the previously problematic conveyor systems. The installation of the MaxZone® Skirting System and XN Liners® resulted in the complete elimination of spillage and a significant reduction in airborne dust. In turn, the time and effort required for housekeeping has significantly decreased, enhancing operational efficiency.
