Fugitive Dust Issues Resolved with MaxZone®

PROBLEM SUMMARY

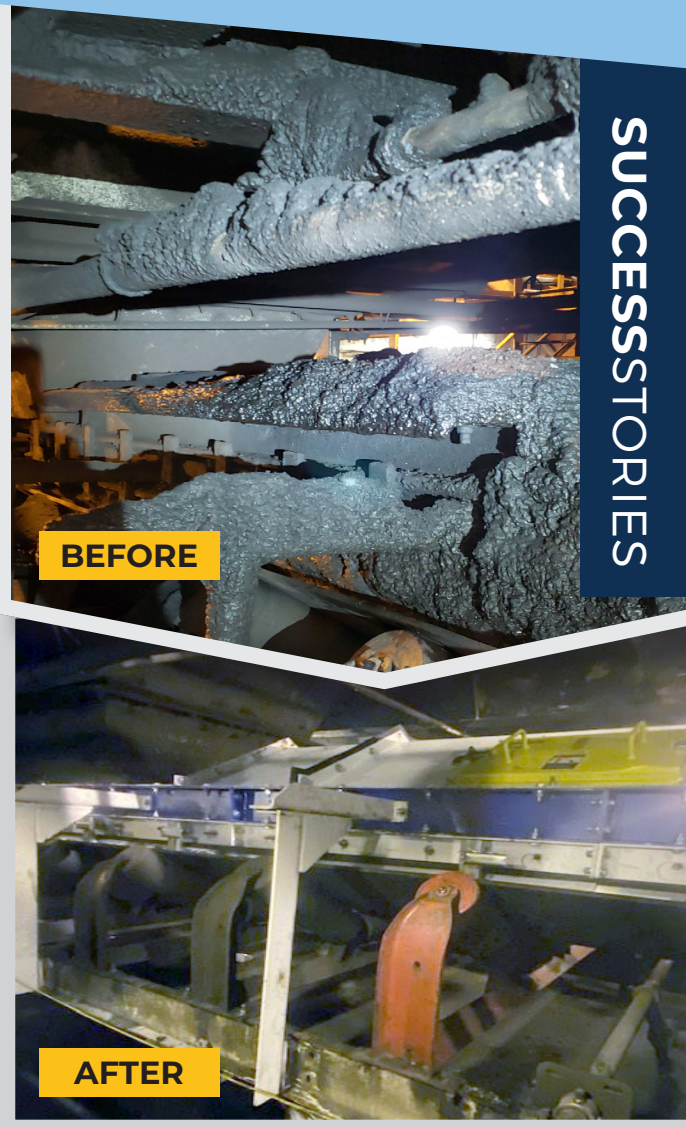
- **MaxZone® Load Zone System** — A belt enclosure system with easy-to-access, externally adjusted skirtboards; internal wear liners; dust curtains designed to disrupt air flow streams and prevent dust escaping the enclosure; and rubber skirting to prevent dust leakage along the sides of the conveyor.

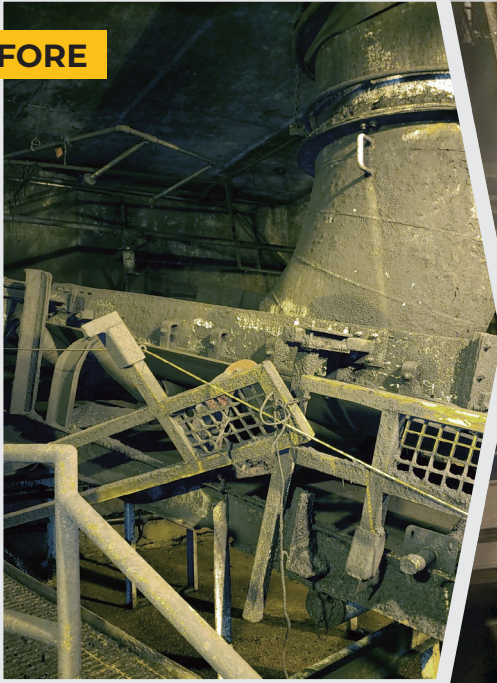
BEFORE

A coal plant located in the southern United States encountered excessive spillage and fugitive dust challenges due to subpar equipment performance. The load zone skirting systems integrated with two conveyors in the rotary car dump building showed signs of extensive wear and aging.

Consequently, the skirting systems' operational effectiveness had significantly diminished, leading to the accumulation of substantial material piles. Furthermore, the dust emissions during material transfer posed serious safety concerns, compromising the overall working conditions.

The installation of a custom-fabricated MaxZone skirting system resulted in highly satisfactory outcomes, aligning with both Benetech's and the customer's expectations. These innovative solutions have substantially reduced maintenance demands by successfully mitigating material spillage. The implementation of effective sealing measures has effectively resolved the issue of excessive dust, further contributing to the improved operational environment.

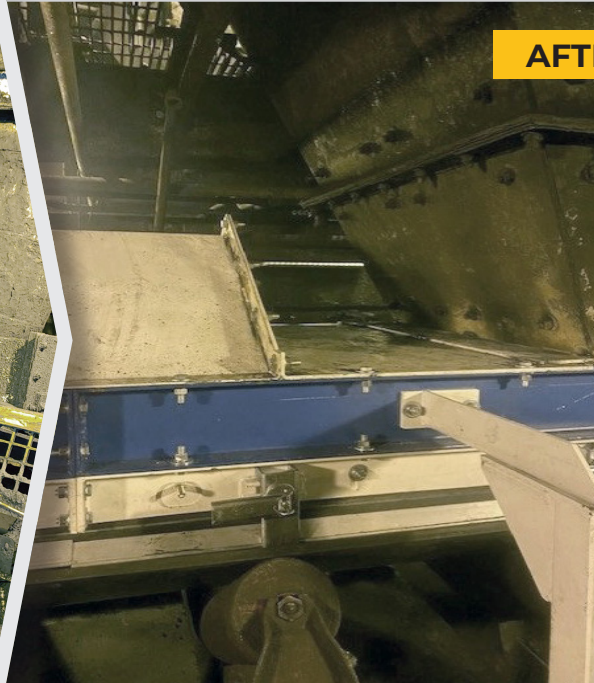
AFTER

By implementing comprehensive solutions, the plant now has a functional system that curbs spillage and dust-related problems. Benetech's diligent approach ensured enhanced efficiency and safety at the coal plant, aligning with the industry's best practices and standards.
