# Load Zone Upgrade

## Eliminated Material Spillage

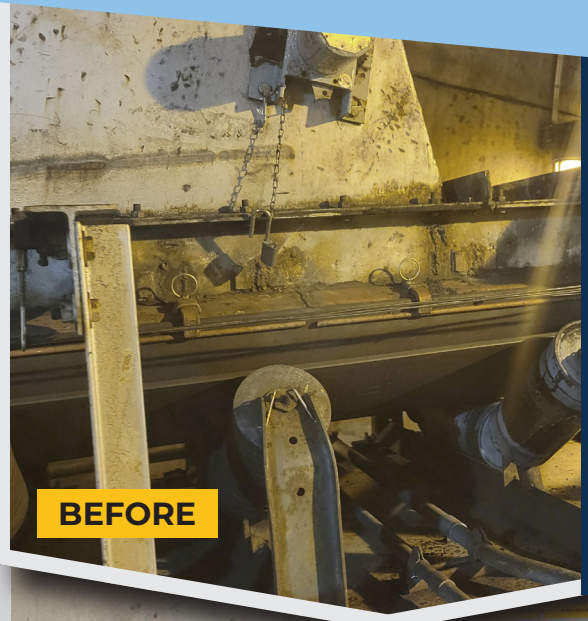
**BEFORE**

The plant had three loading points feeding a single 36-inch conveyor belt, transporting coal from an above-ground pile to silos. The main conveyor line experienced severe offside loading from all three points, causing the belts to frequently misalign. An outdated, non-functional skirting system exacerbated the issue, causing significant material spillage, increased housekeeping efforts, and maintenance headaches.

The MaxZone Plus® system was installed to direct material to the belt's center, ensuring even distribution and reducing spillage. Its modular design allows for easy installation and maintenance. The Skirtboard system, with high-abrasion liners, protects against wear, while the XN Liners guide material smoothly onto the belt, reducing misalignment. Additionally, B Plus skirt rubber was used for its durability and effectiveness, further enhancing the system's performance. Finally, a thorough cleanup of the plant, addressing the accumulated spillage and improving overall safety and cleanliness, was conducted.
