# Severely Rusted Load Zones & Transfer Chutes

A bulk handling terminal in the southern U.S. handles inbound shipments of salt, potash, and phosphate from ocean vessels and barges. The transfers involved in this project were on the inbound ship unloading conveyors and were part of a three-year-old section of the plant.

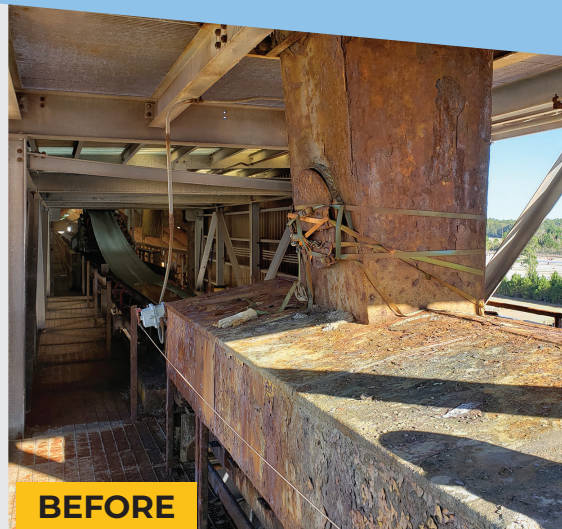
**BEFORE**

The transfer chutes were aging, requiring upgrades to achieve the following primary goals:

Benetech's engineering team suggested a **properly designed load zone solution** that included: a belt enclosure; wear liner skirtboards for material containment; dust curtains to disrupt airflow streams and dust escaping the enclosure; and rubber skirting to prevent dust leakage along the sides of the conveyor.

It also included a **strong belt support system**. Adequate belt support in the loading area of a conveyor is critical to the performance of the containment system.

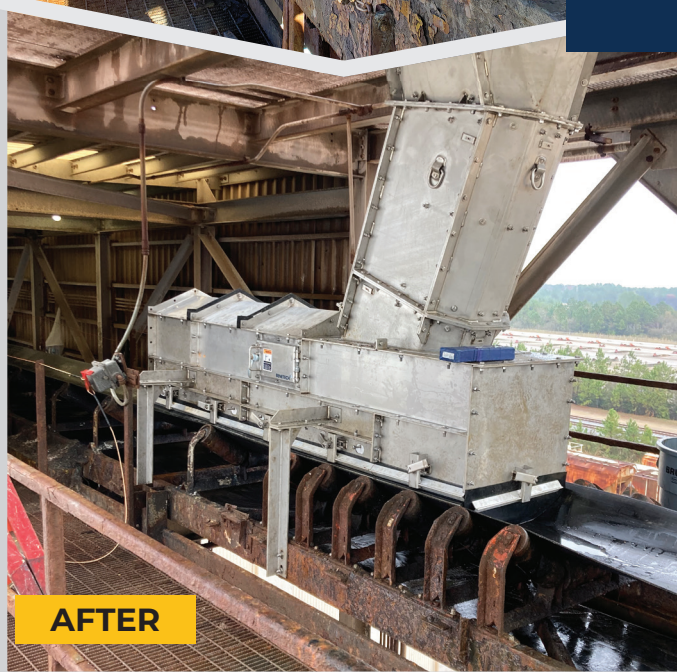
**AFTER**

After installation, the operation saw significant improvements across multiple problem areas. Airborne dust levels dropped and salt water corrosion was greatly reduced.

Additionally, material spillage at the transfer points was virtually eliminated. Cleanup requirements were greatly reduced, allowing maintenance teams to focus on more critical tasks. Overall, the upgrades improved site safety, reduced labor demands, and enhanced system reliability.

1. **MaxZone® Load Zone System** — A belt enclosure system with easy-to-access, externally adjusted skirtboards;

internal wear liners; dust curtains designed to disrupt air flow streams and prevent dust escaping the enclosure; and rubber skirting to prevent dust leakage along the sides of the conveyor.

**2. Engineered Transfer Chutes & DEM** — Custom-designed transfer chutes using Discrete Element Method (DEM) Flow Analysis greatly minimize production problems, including pluggage or choked flows, eliminating spillage and airborne dust, reducing high-impact areas, optimizing belt life, and creating longer intervals between service and maintenance.

**3. Inspection Doors** — Stainless steel, rust-resistant, dust-tight doors that minimize airborne dust and spillage while also allowing access for service and maintenance.
