MaxZone® System Installation STOPPED EXCESSIVE SPILLAGE

PROBLEM SUMMARY

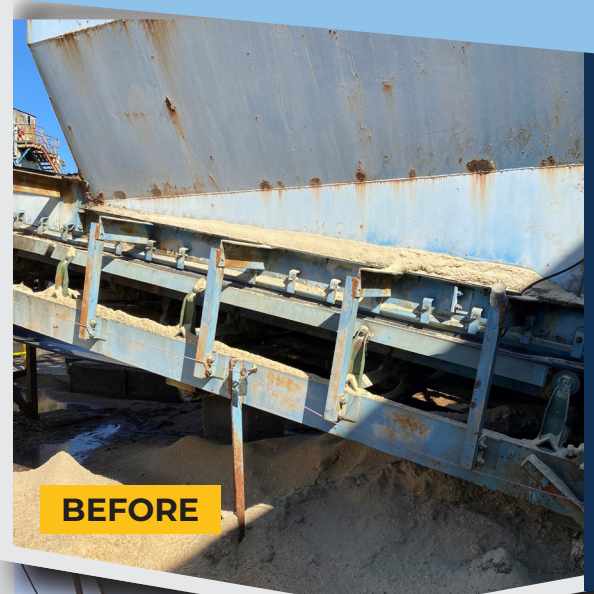
A wood chip paper mill in Georgia was experiencing severe issues with material spillage. The mill faced persistent problems of material escaping through the existing skirting, causing not only significant product loss but also requiring frequent clean-up efforts.

BEFORE

Benetech's solution for mitigating material spillage at the wood chip paper mill encompassed a strategic combination of cutting-edge products and tailored engineering expertise. The solution comprised a MaxZone Load Zone System which included XN Liner Wearliners and a two (2) foot tail box. This provided robust containment for the wood chips while minimizing product loss.

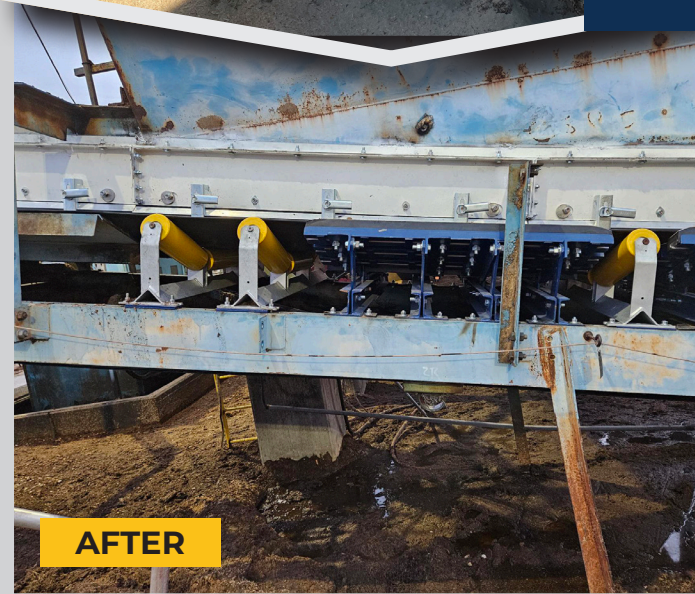
AFTER

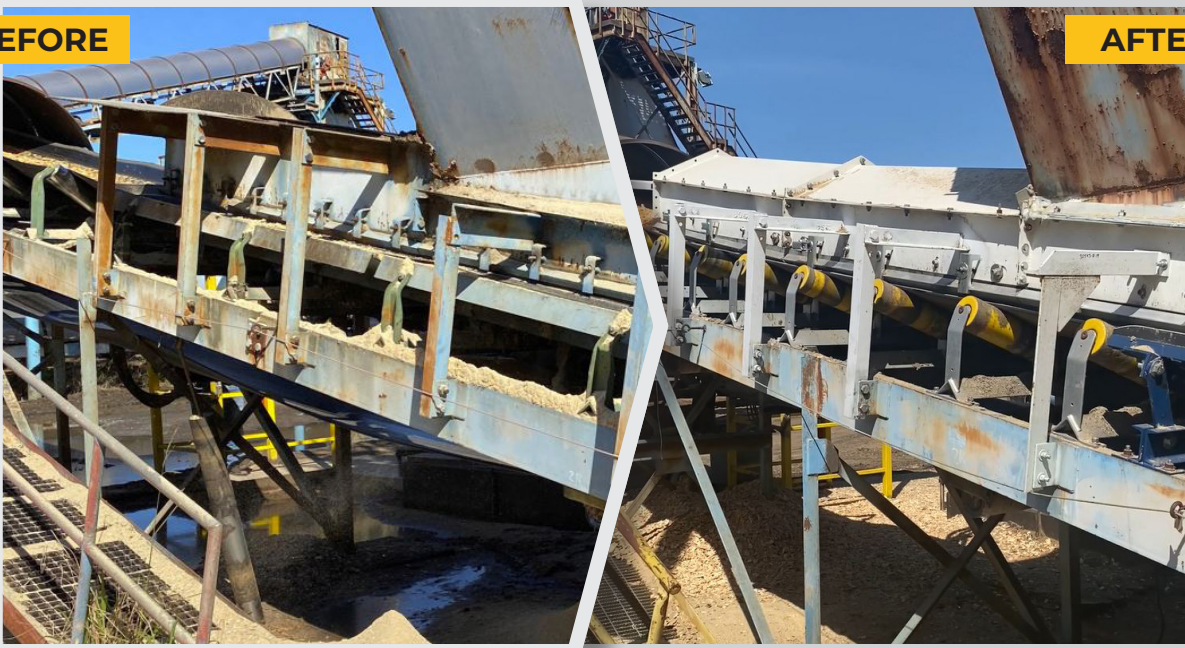
The implementation of Benetech's solutions yielded remarkable results, significantly exceeding the expectations of the paper mill management. The reduction in material spillage post-implementation was exceptional, with a staggering 99% decrease observed. This drastic reduction not only diminished product loss but also alleviated the need for extensive clean-up efforts, streamlining operational processes and enhancing workplace safety.

AFTER
