# BENETECH. Severe Glass Spillage Eliminated with MaxZone® System

## PROBLEM SUMMARY

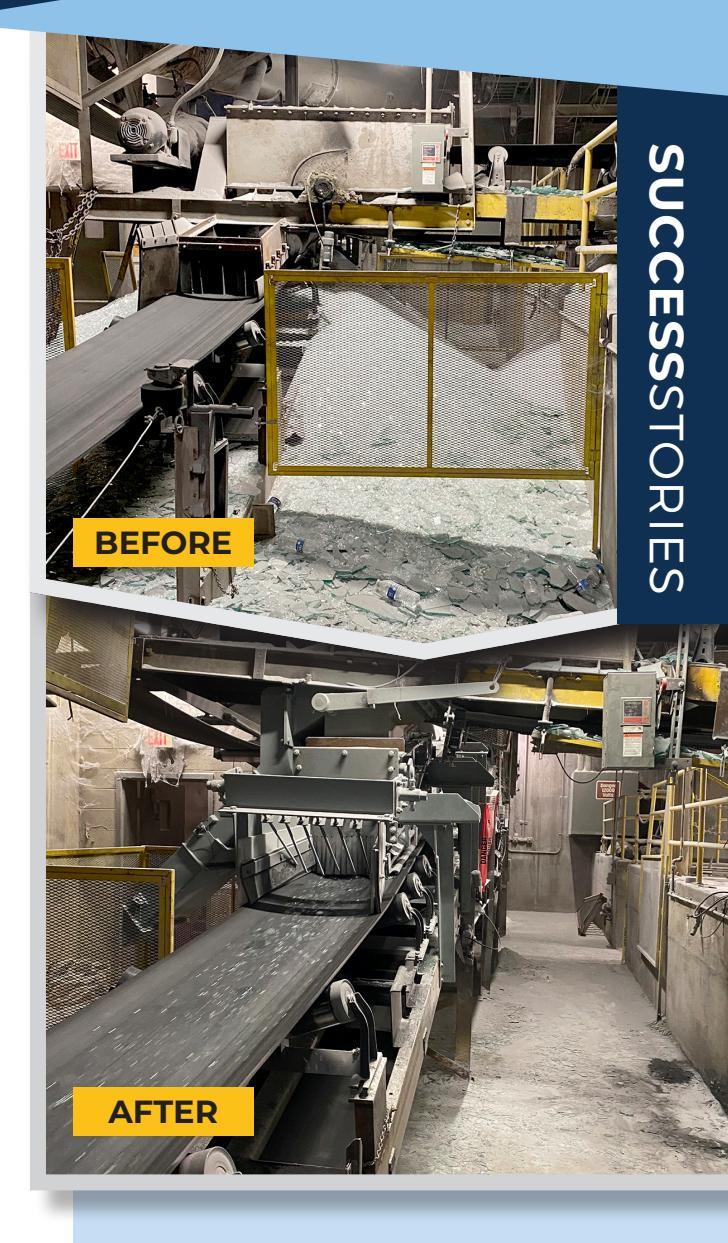
MaxZone<sup>®</sup> Premium Load Zone System — A belt enclosure system with easy-to-access, externally adjusted skirtboards; internal wear liners; dust curtains designed to disrupt air flow streams and prevent dust escaping the enclosure; and rubber skirting to prevent dust leakage along the sides of the conveyor.

Benetech's engineering team recommended multiple solutions to improve flow and reduce spillage. Engineered discharge chutes were designed using DEM flow modeling and Inventor CAD software to simulate smooth transfer loading onto the feed belts.

The conveyor, head box, and related structure were raised five degrees (for a total of approx. 30 in.) in order to improve loading and to provide a solid foundation for the Installation of the MaxZone Plus<sup>®</sup> and MaxZone<sup>®</sup> Premium skirtboard sealing system.

Additionally, the "belt lifting" system was removed by creating a straight belt line and utilizing multiple height Idler standoff risers for the nine (9) Benetech Drop & Slide<sup>®</sup> Idlers and conveyor belt support components.

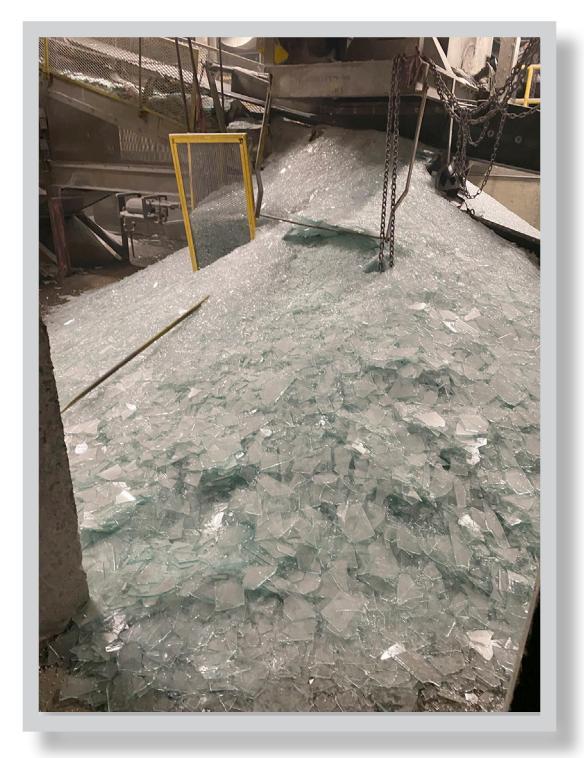
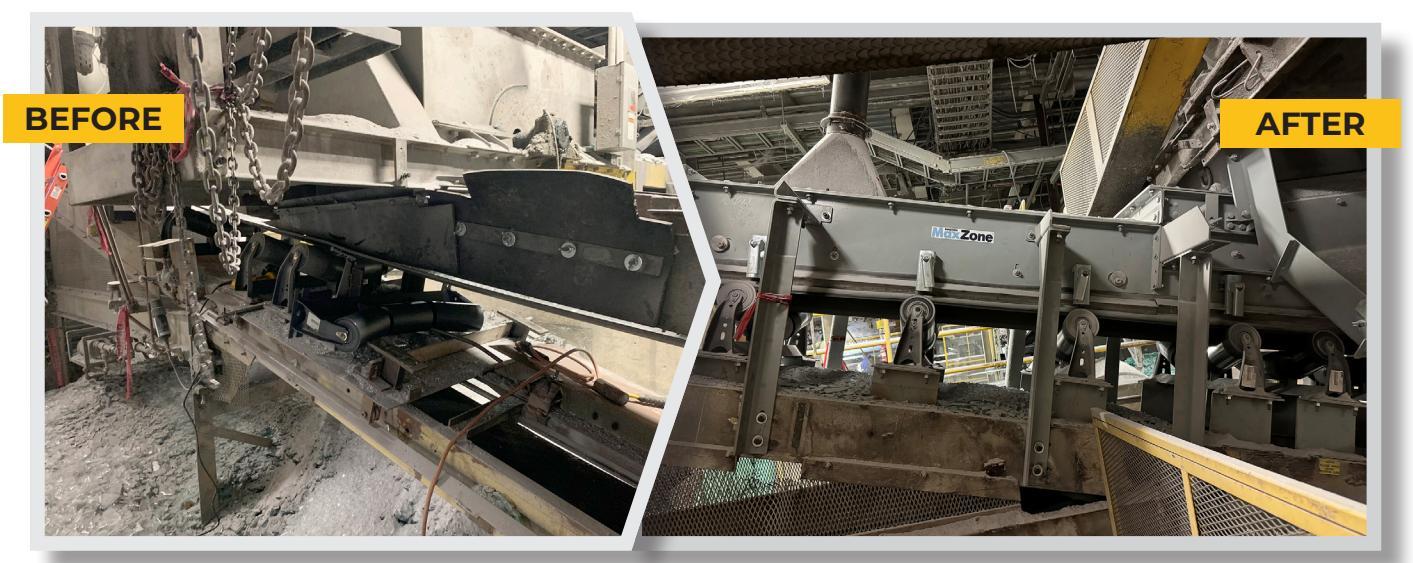
Benetech's MaxZone<sup>®</sup> products and engineered transfer chutes were designed and installed, showing immediate, highly effective results, with little to no carryback on the inclined conveyor.

Overall, material flow was greatly improved at transfer points, resulting in less maintenance and clean-up hours, reduced material loss, and improved air quality.
