# Severe Fugitive Dust & Spillage Problems

## MAXZONE® INSTALLATION

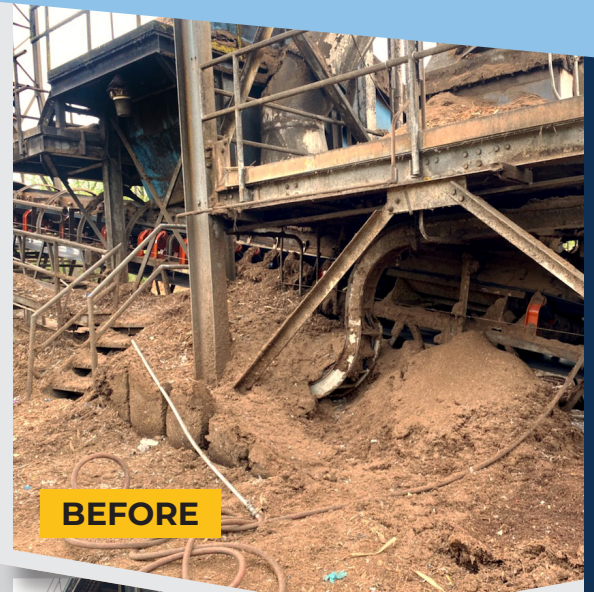
BEFORE

A large portion of its support structure, main conveyor, and three entrance chutes had become dangerously misaligned from its original plumbed orientation and had sagged unevenly over its almost 50-year life span.

Not only was the facility experiencing long amounts of time with clean-up, but they were also losing valuable product due to its severe spillage.

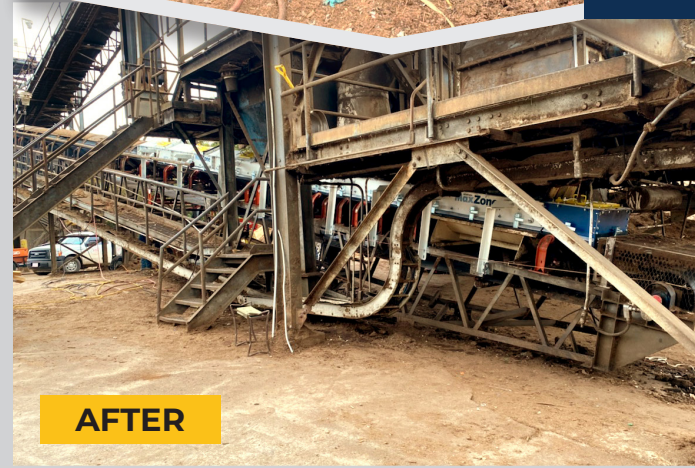
AFTER

- 1. MaxZone® Load Zone System** — A belt enclosure system with easy-to-access, externally adjusted skirtboards; internal wear liners; dust curtains designed to disrupt air flow streams and prevent dust escaping the enclosure; and rubber skirting to prevent dust leakage along the sides of the conveyor
- 2. Simple Slide Idlers** — Roller frames that slide into place without the need to remove adjacent idlers, resulting in excellent serviceability and improved safety

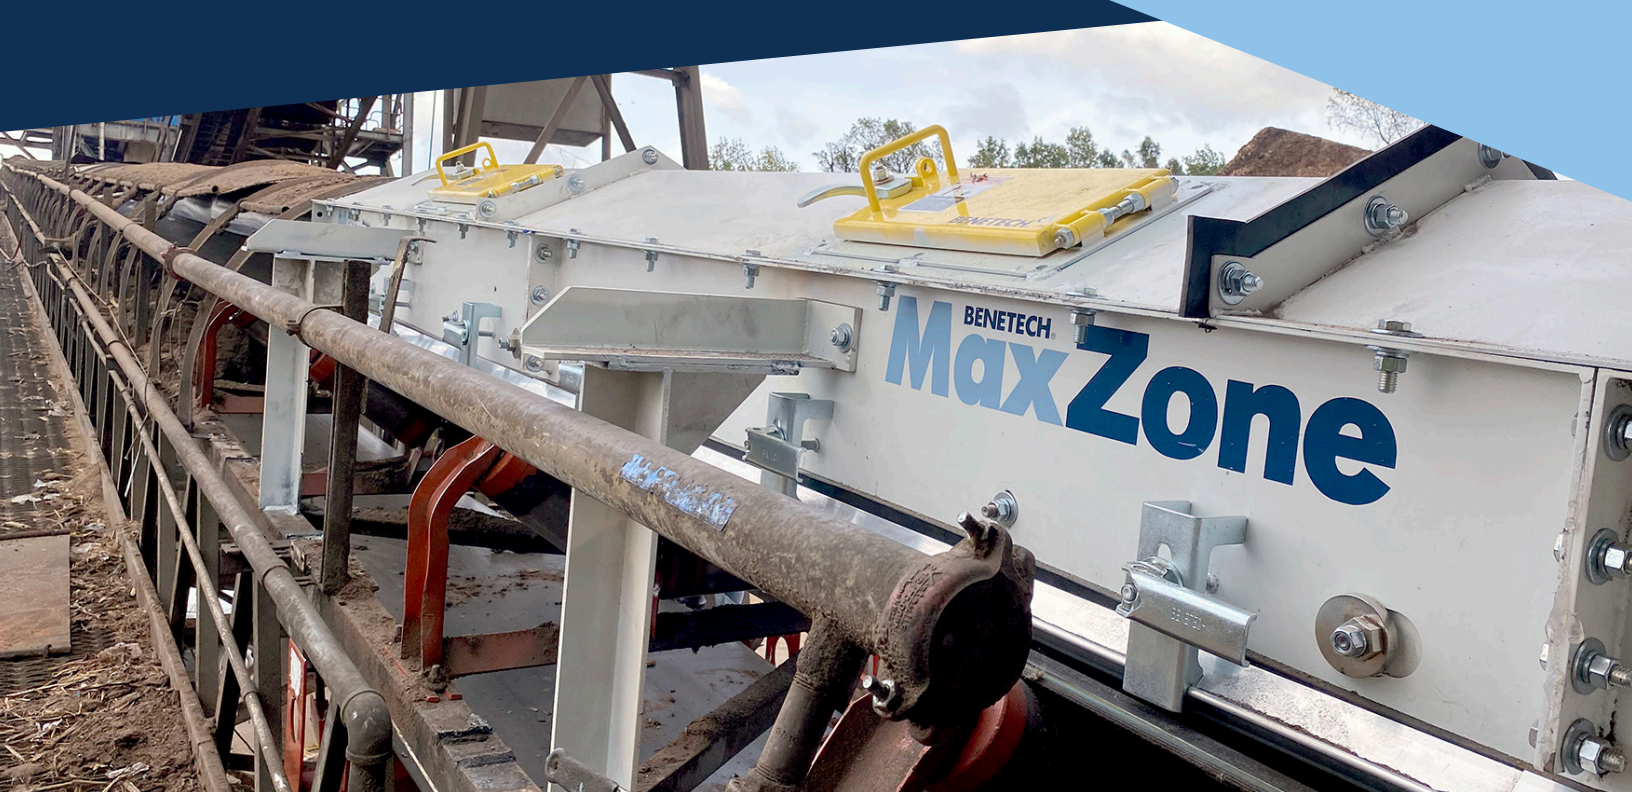
Benetech provided best-in-class belt support critical to the performance of the containment system (skirtboard and enclosure above the belt) including simple slide idlers and belt trackers. Minimizing belt oscillation and providing a flat level surface for the belt to be loaded was critical for optimum performance.
