# Enhancing Performance with Conveyor Upgrades

## PROBLEM SUMMARY

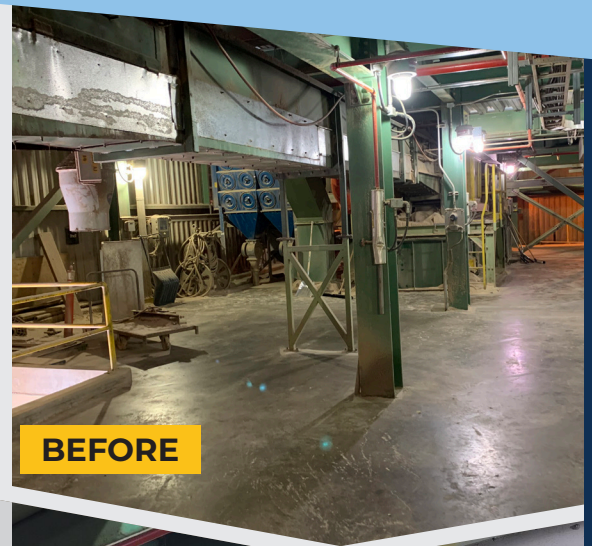
**BEFORE**

A pulp and paper facility in Canada was experiencing significant operational challenges due to old drag chain and paddle conveyors. The drag chain conveyor caused frequent chute pluggage from material carryback, which restricted flow and led to unplanned downtime. The paddle conveyor generated excessive fugitive dust and spillage and required a complex material flow path that made maintenance more difficult. Additionally, limited access around the drag conveyor further complicated routine inspections and servicing.

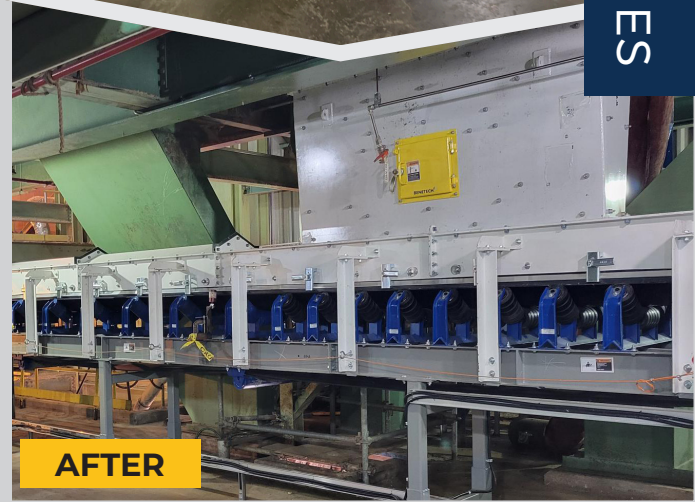
**AFTER**

The upgraded conveyor system significantly improved reliability, safety, and maintainance. Material now moves along a more direct, efficient path with minimal carryback and reduced dust.

To address these challenges, Benetech implemented a comprehensive conveyor system upgrade during a scheduled outage. The outdated drag chain and paddle conveyors were replaced with a traditional 24-inch reversing belt conveyor designed to streamline material handling and improve access for maintenance.
